Property surveyed

1, Folgate
Wreningham
NORWICH
NR16 1AS

Report Reference No: 3086211

Date: 26-Jun-2012

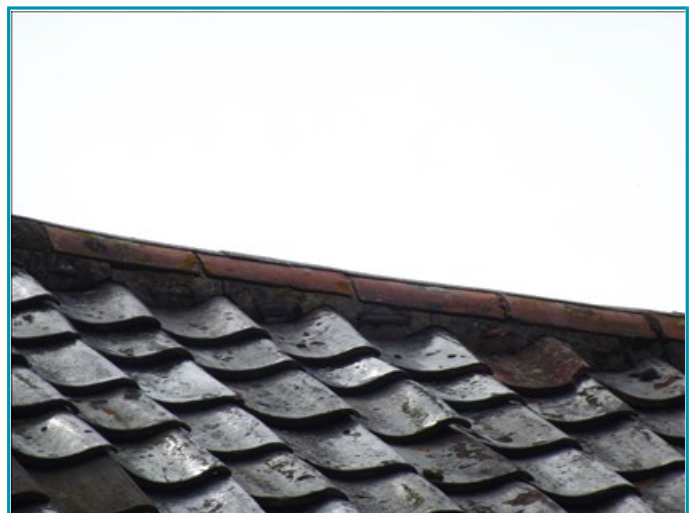
Loose ridge tiles to the main roof.

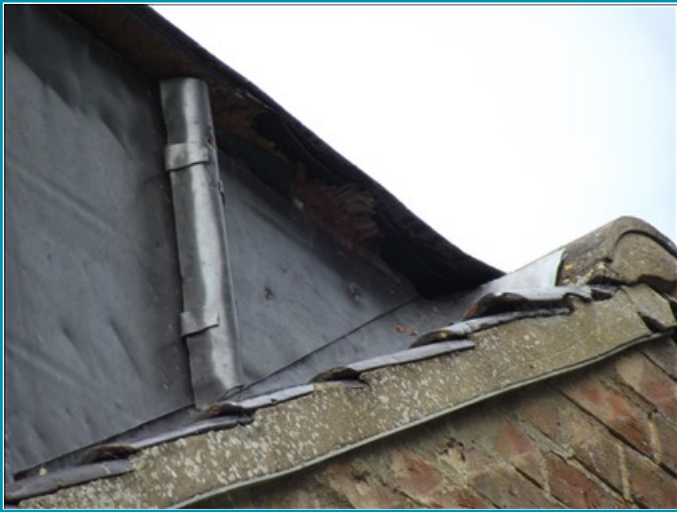
No fascia or aris cut to the left hand side of the rear dormer.

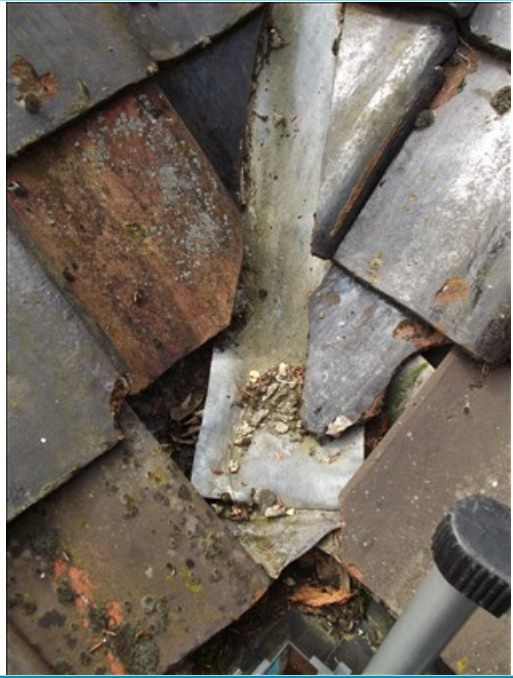
Roof valley not finished at bottom with tiles missing above rear Entrance Door.

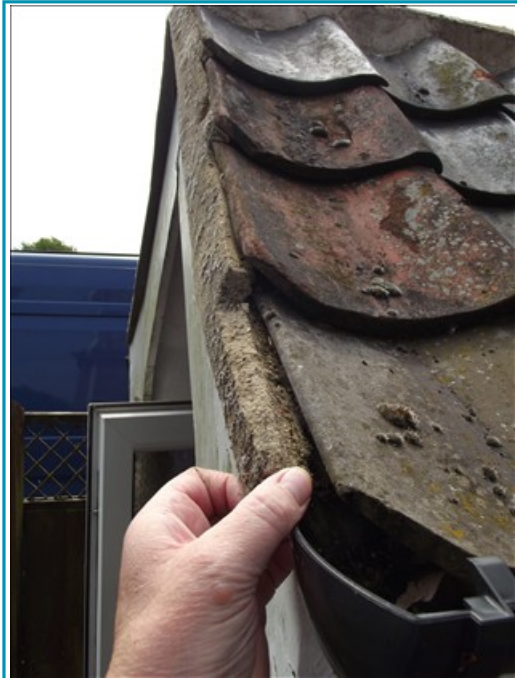
Loose verge cement to gable end over rear Entrance Door.

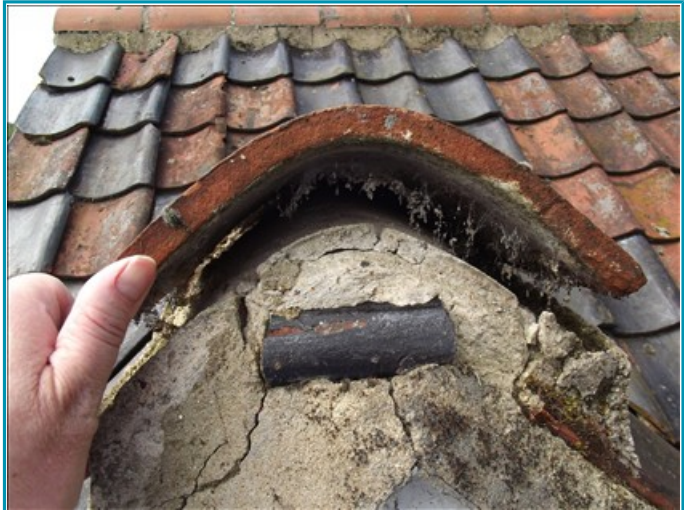
Loose ridge tile above rear Entrance Door.

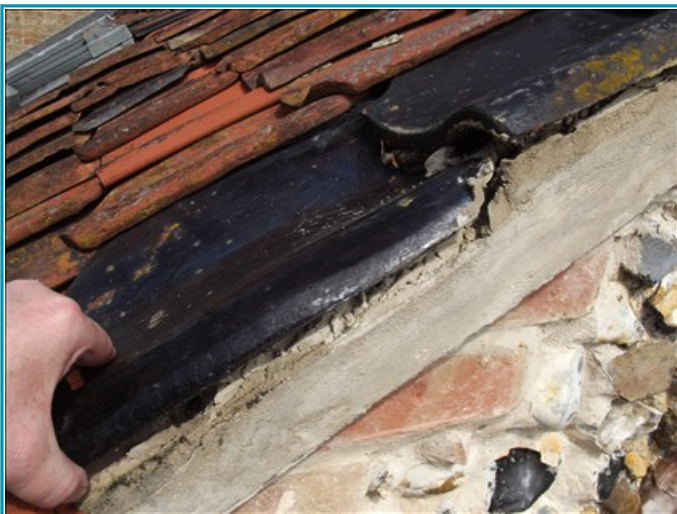
Loose verge tile to the rear single storey gable end.

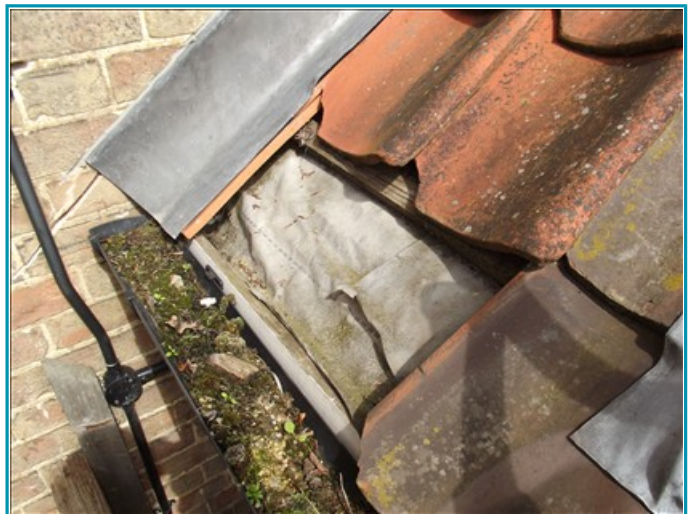
Two roof tile missing from the rear roof elevation over the Breakfast room.

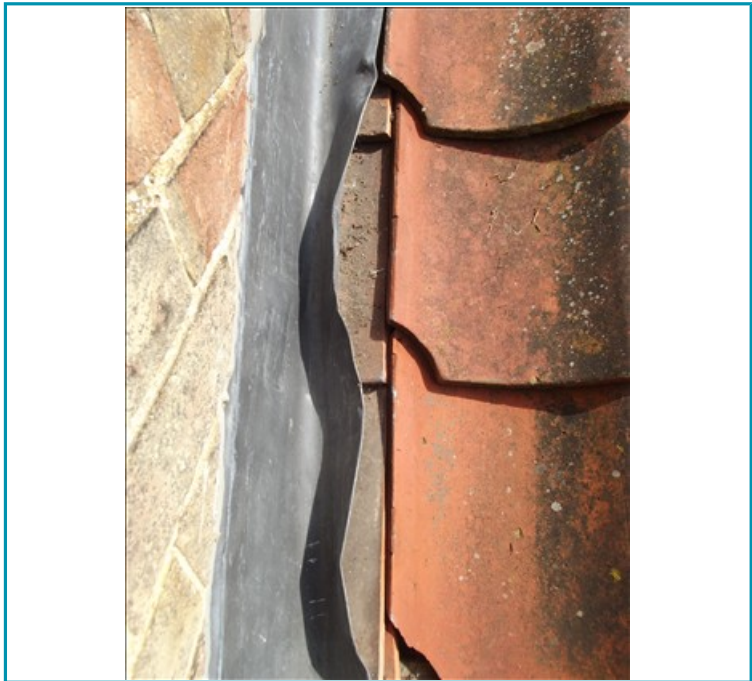
No overlap to roof tiles where they are cut at the flashing to the rear single storey roof.

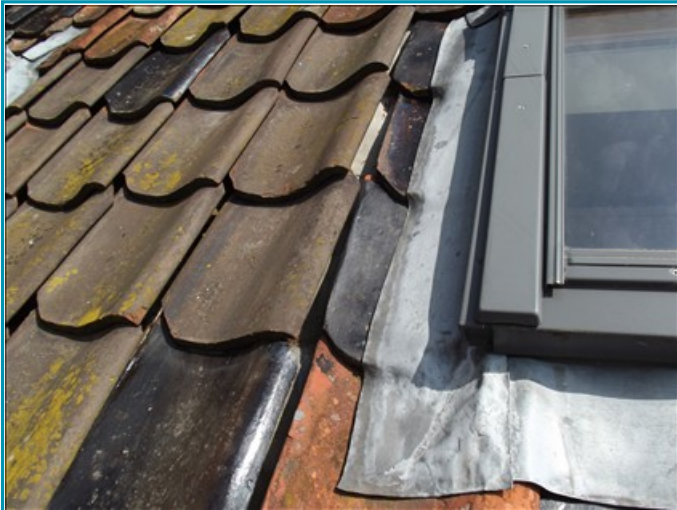
Roof tiles set out so badly they are not over lapping.

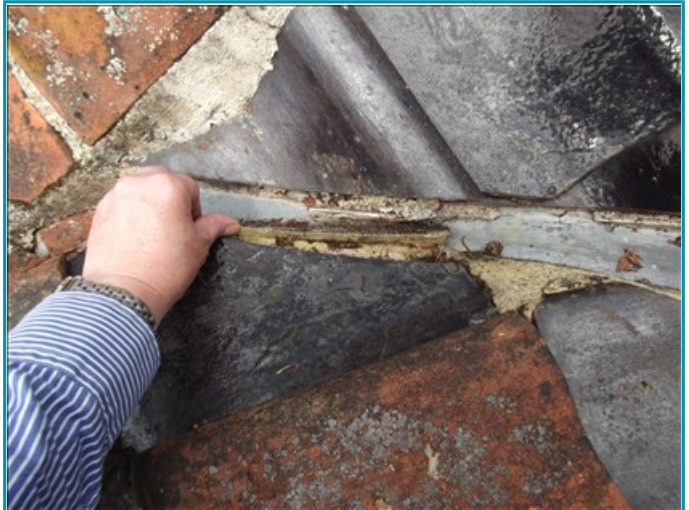
Loose cement parging to roof valley.

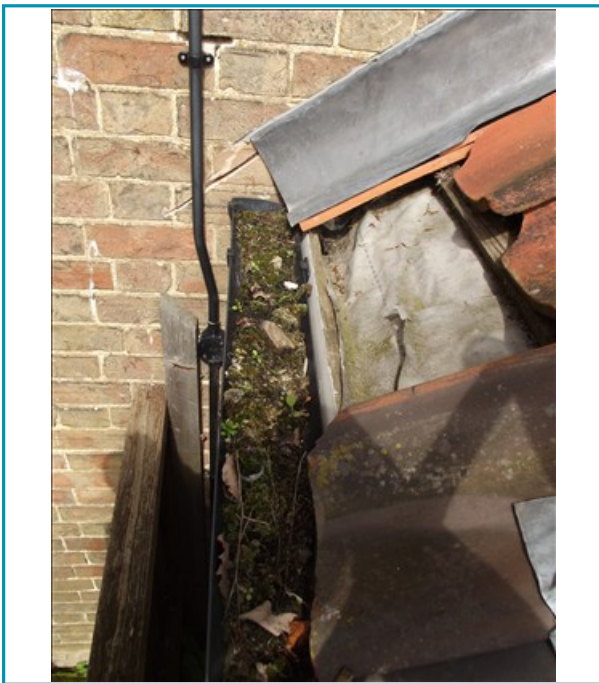
Debris was noted in the rear single storey guttering this should be cleared. Gutter cleaning should be an annual event and carried out under normal maintenance. The rain water from the rear single storey guttering discharges via rain water pipe along the rear of the timber shed to discharge on to the neighbours rear entrance driveway which is constructed of shingle. Although not causing a problem at present this situation is not ideal. Some repairs or replacements are required but these are not considered serious or urgent.

Debris in rear guttering to single storey rear Kitchen/Breakfast room.

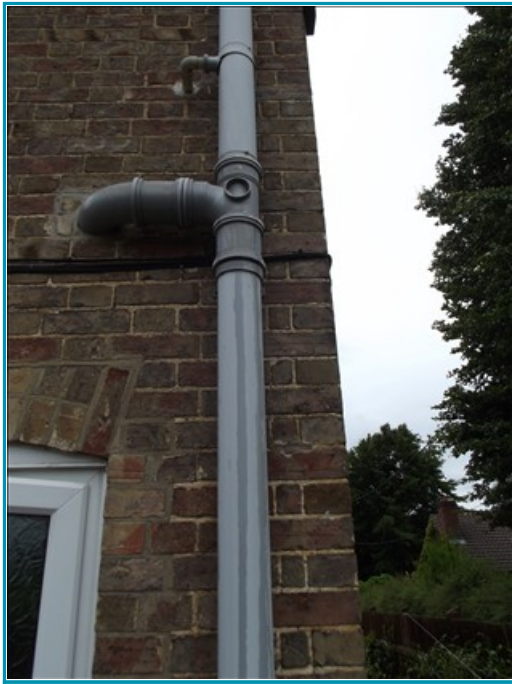
<p>D4. Above ground waste & soil pipes</p>	<p>The SVP (soil vent pipe) is to the rear elevation of the property and is of grey UPVC construction.</p> <p>When the upstairs toilet was flushed it was noted that the SVP was leaking out of a joint towards the top. This is considered serious and in need of urgent repair or replacement.</p>	<p>3</p>
---	--	----------

Leaking SVP.

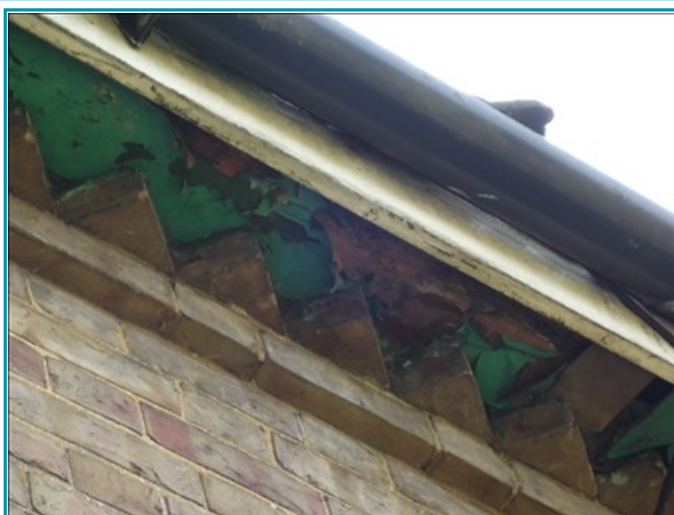
<p>D8. All other woodwork</p>	<p>All other woodwork includes painted softwood fascias, soffits, barge boards and white UPVC fascias and ventilated soffit.</p> <p>The front painted softwood soffit was starting to rot to the right hand side. This suggests the eaves sarking felt has rotted at eaves level to the front elevation allowing rain water on to the soffit. Please see Roof Covering D2. The left hand fascia is missing from the rear dormer flat roof. As these seemed to have been formed in a fibre glass material and are forming part of the flat roof by forming an aris cut I have dealt with this under Roof coverings please see D2. This is considered serious and in need of urgent repair or replacement.</p>	<p>3</p>
---	--	----------

Rot to softwood soffit on front elevation.

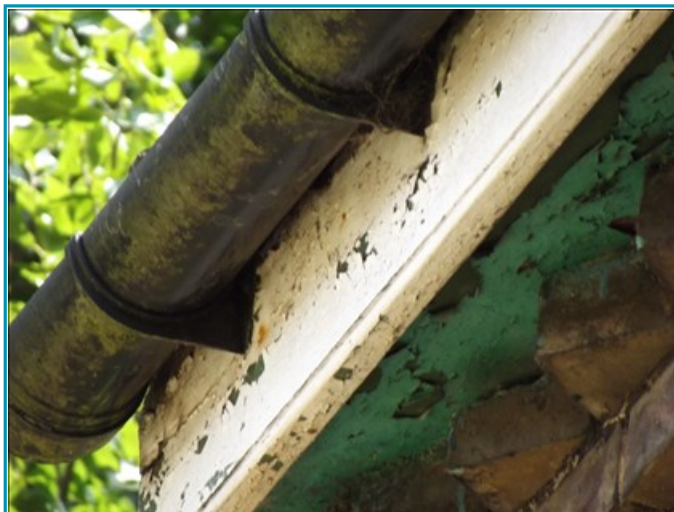
<p>D9. Outside decoration</p>	<p>Paint to softwood fascias, soffits and barge boards.</p> <p>Flaking paintwork was noted indicating re-painting is required in order to stop water penetration of the timbers. This is considered serious and in need of urgent repair or replacement.</p>	<p>3</p>
---	--	----------

Flaking paintwork to front elevation softwood fascias and soffit.

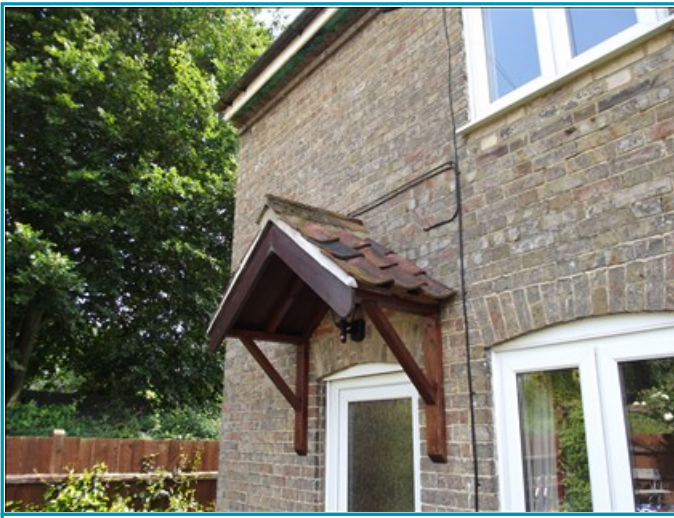
<p>D10. Other outside detail</p>	<p>There is a timber canopy over the front entrance door that is constructed of wood stained softwood hangman brackets supporting rafters and ridge board forming a pitched roof. The roof is covered in clay plain tiles.</p> <p>There was no lead flashing between the roof and the main wall of the house. Some repairs or replacements are required but these are not considered serious or urgent.</p>	<p>2</p>
--	---	----------

No lead flashing at the junction with the canopy roof and main wall.

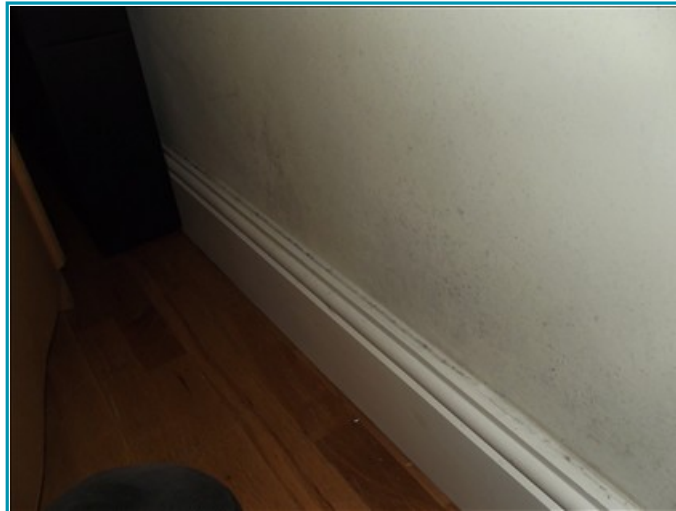
Mould spores to exterior wall in under stairs area.

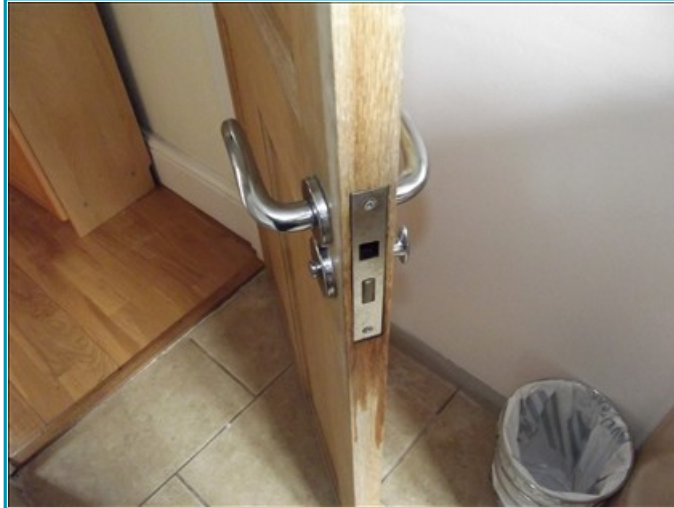
<p>E7. Inside woodwork</p>	<p>Inside woodwork includes painted softwood skirtings, architraves, oak internal doors, staircases and window sills.</p> <p>The door latch was missing from the Bathroom door. Some minor creaking was noted to the ground floor staircase treads. Some repairs or replacements are required but these are not considered serious or urgent.</p>	<p>2</p>
---	---	----------

No latch on Bathroom door.

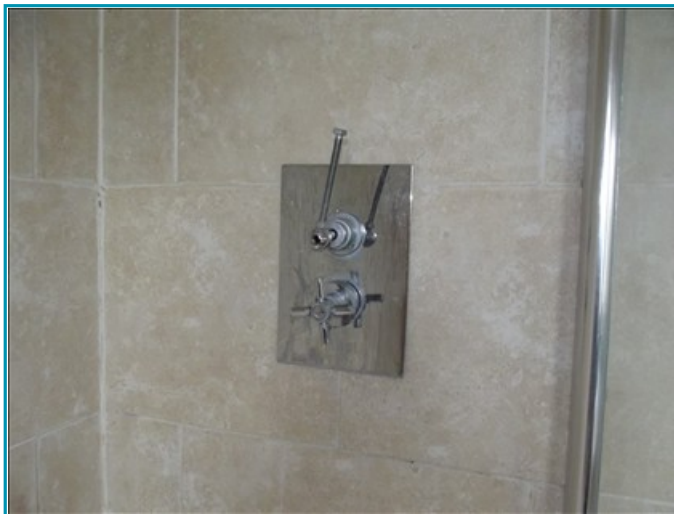
<p>E8. Bathroom fittings</p>	<p>The main Bathroom consists of a white acrylic bath with a mixer shower over and a glazed screen, white vitourous china basin in a vanity unit and a toilet with a hidden cistern. The first floor Cloakroom consists of a white vitourous china close coupled toilet and basin. The ground floor Cloakroom consists of a white vitourous china hidden cistern toilet and basin.</p> <p>The handle operating the mixer shower must have broken as a bolt is now being used as a handle. Some repairs or replacements are required but these are not considered serious or urgent.</p>	<p>2</p>
---	---	----------

Bolt used as handle on mixer shower.

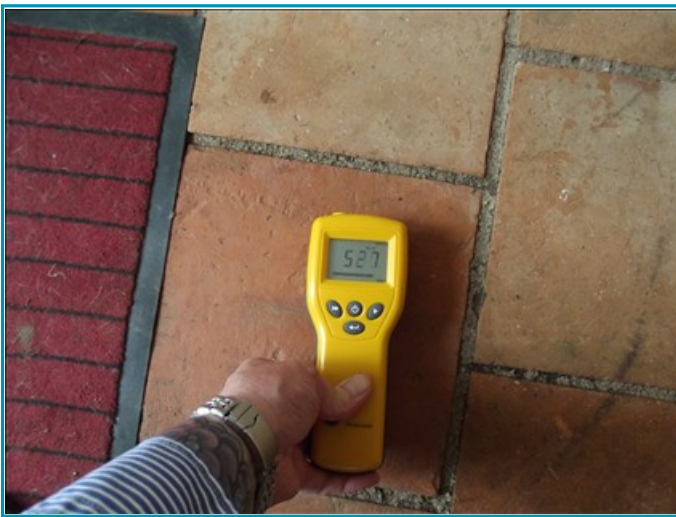
<p>Dampness was found by moisture meter testing to the clay pamment floor in the rear lobby and Cloakroom and timber skirting's and lower walls in the rear Lobby. This is believed to be rising damp. A solution here would be to remove the clay pamment and plaster up to 1m in height and apply a tanking solution to the floor slab and walls before re-laying the pamment and re-plastering. At risk moisture meter readings of 18.9% WME were found to the timber skirting's to the under stairs cupboard. I noted that the exterior ground levels around the main part of the property are only just below internal floor levels. It would be prudent to dig a spades width trench around the property and form a French drain.</p>

Damp to clay pavement floor tiles in rear Lobby.

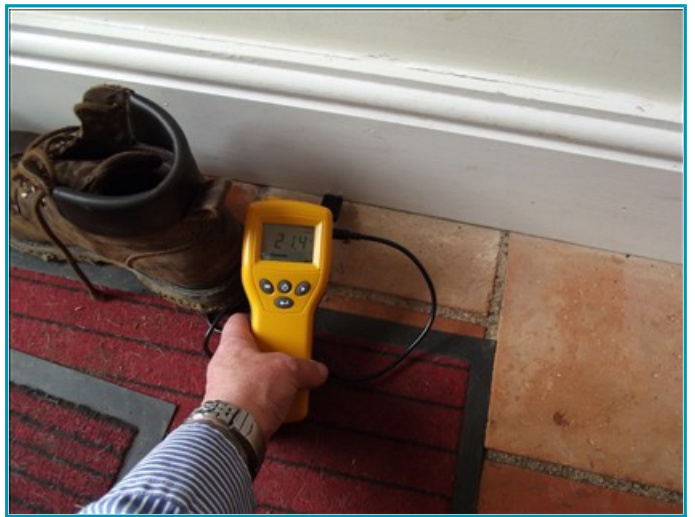
Damp to skirtings in rear Lobby.

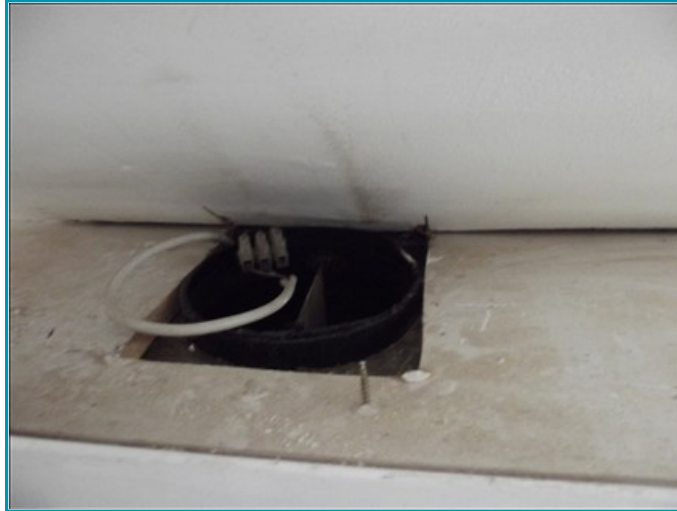
<p>E9. Other issues</p> <p>Extractor fans</p>	<p>There was a cooker hood and electric extractor fan in the Kitchen however this was not connected to the exterior. There was no extractor fan fitted in the Bathroom.</p> <p>Connect the Kitchen cooker hood up to the exterior and fit an extractor fan to the Bathroom. This will remove moisture at source and help reduce any condensation problems in the winter months. This is considered serious and in need of urgent repair or replacement.</p>	<p>3</p>
--	---	----------

Cooker hood extractor fan is not connected to the exterior.

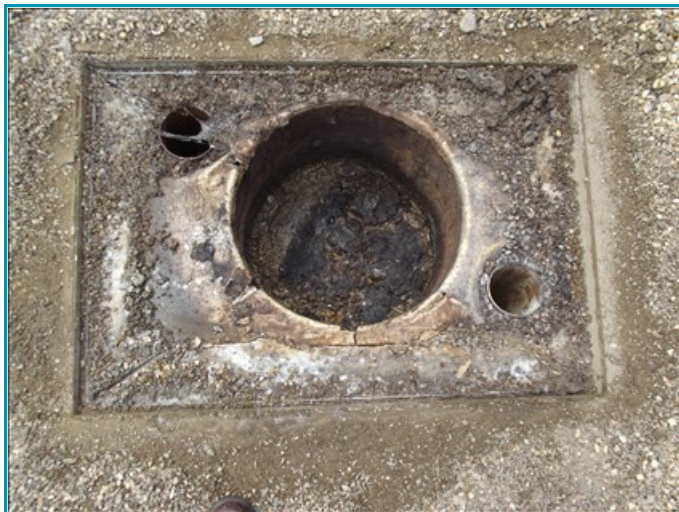
<p>F6. Drainage</p>	<p>The drains start at the rear of the property with the SVP which is of grey UPVC construction. The drains then run in 100mm diameter UPVC pipe through two UPVC ICs (inspection chambers) and then in to the septic tank which is located to the rear car standing area.</p> <p>The lids were lifted to the ICs and the flow observed which was fair. As mentioned under D4 the SVP was leaking at a join to the top. When the lid to the Septic tank was lifted the tank was full and in need of emptying. There is a further man hole cover located to the neighbours rear access driveway. This houses a pumping sump which pumps sewage in to the main sewage system. If you did not want to remain with the septic tank it would be a simple job to connect the household's foul drains in to the main system. This is considered serious and in need of urgent repair or replacement.</p>	<p>3</p>
--------------------------------	---	----------

Septic tank full.
